Plumtree Run Watershed Small Watershed Action Plan

Prepared for
Harford County Department of Public Works
Division of Water Resources
Bel Air, Maryland

Prepared by
BayLand Consultants & Designers, Inc.
and Clear Creeks Consulting, LLC
1321 Mercedes Drive, Suite A
Hanover, Maryland 21076

June 1, 2011

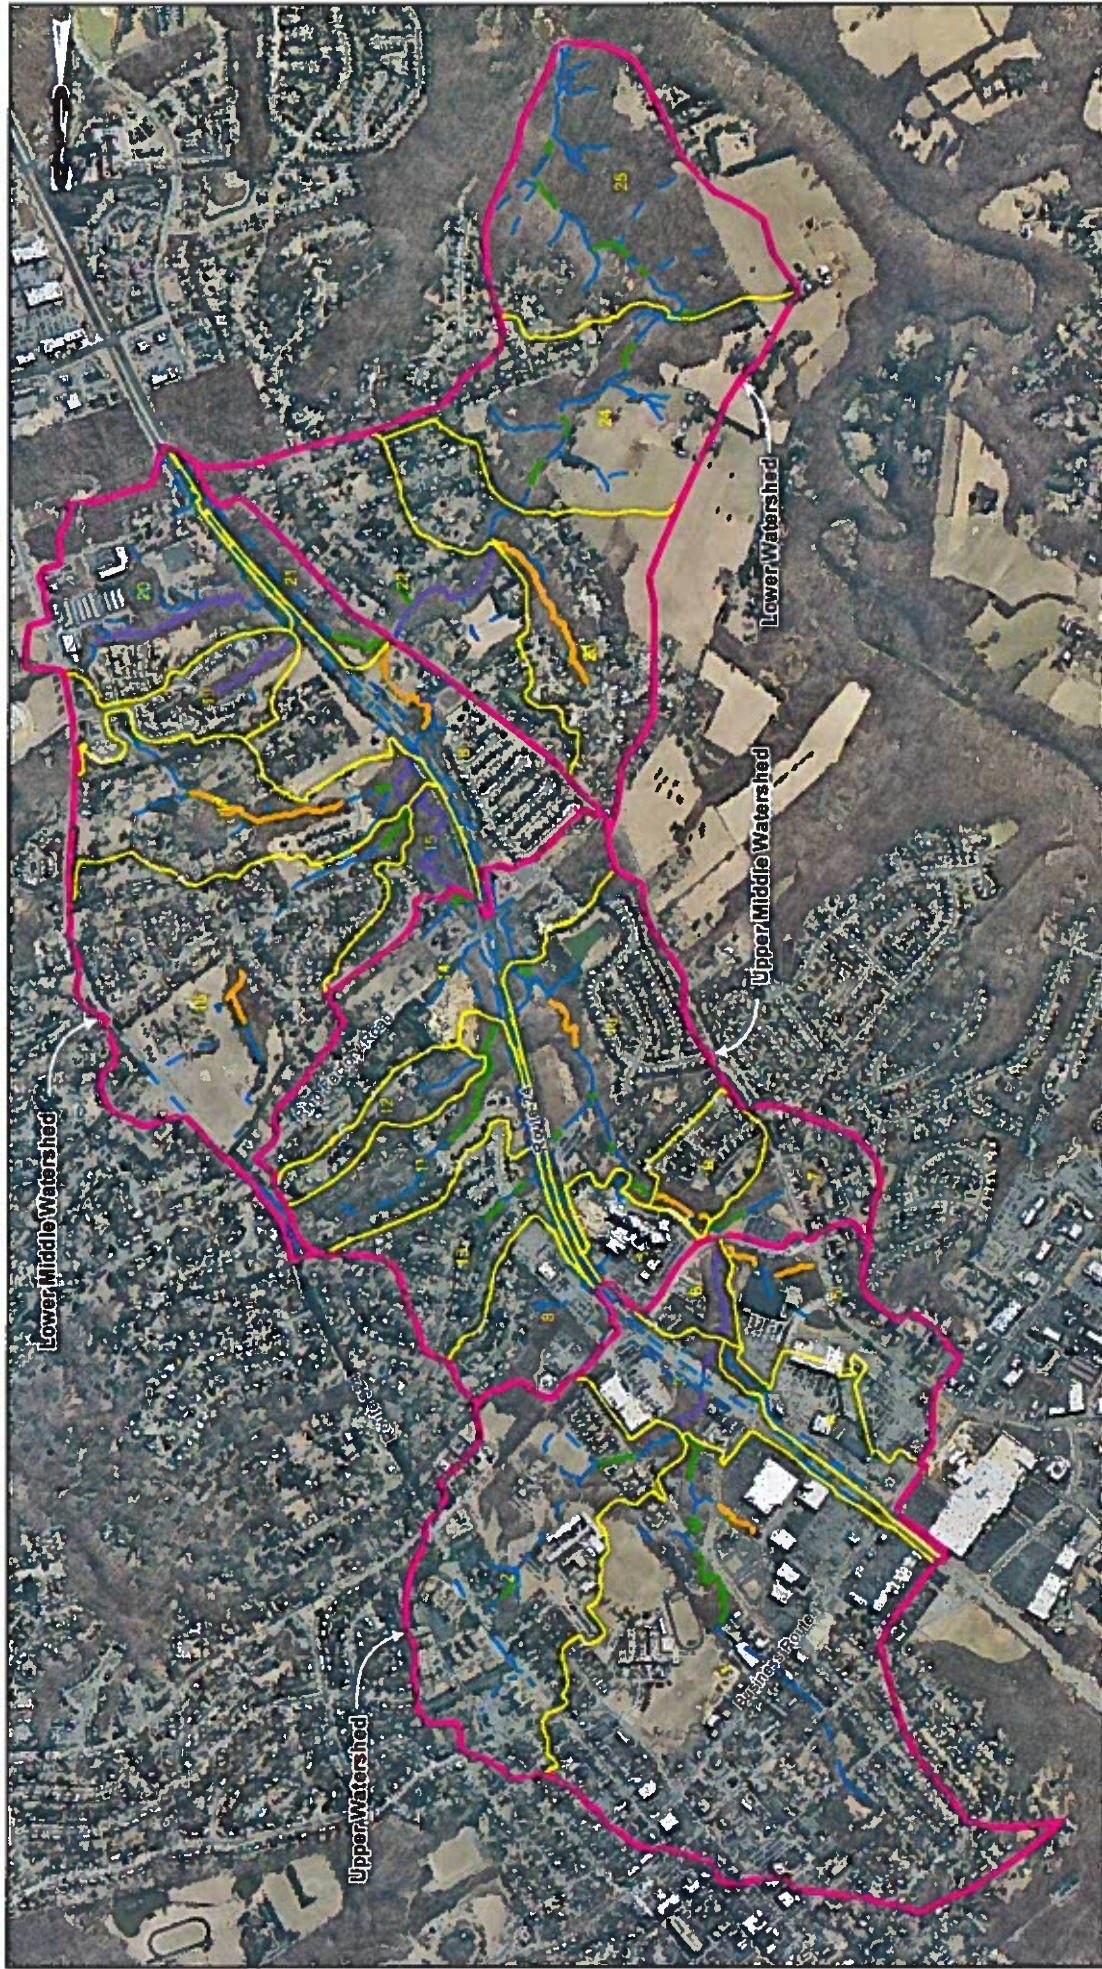
Field observations indicating conditions that could affect public safety, existing or potential damage to public infrastructure, and damage to private and public property also guided the evaluation process. Using the evaluation criteria unstable stream reaches were categorized into Very Low, Low, Moderate, and High categories related to degree of instability. Stream reaches that had been determined to be stable, moderately stable, that is generally stable but with minor and localized erosion or sedimentation, or very low instability were not evaluated further. Unstable stream reaches are show in Figure 4.2.

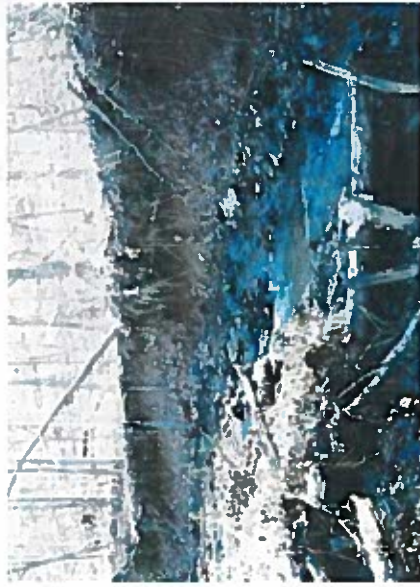
(a) Unstable stream reach

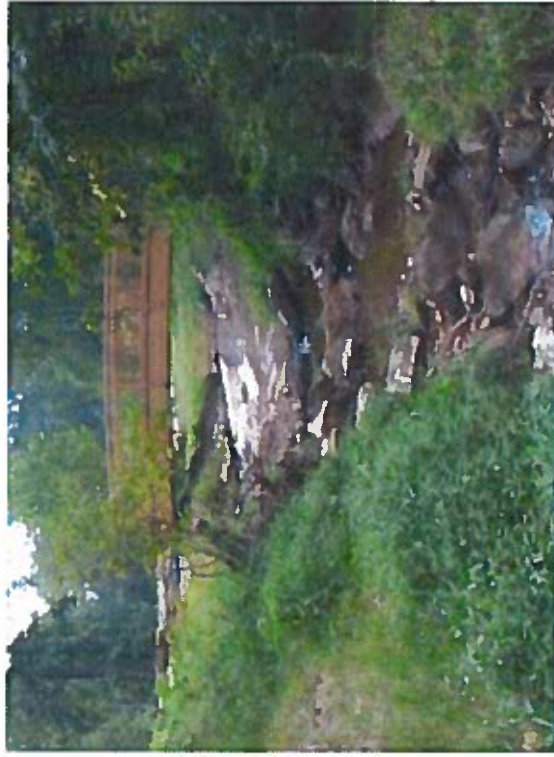
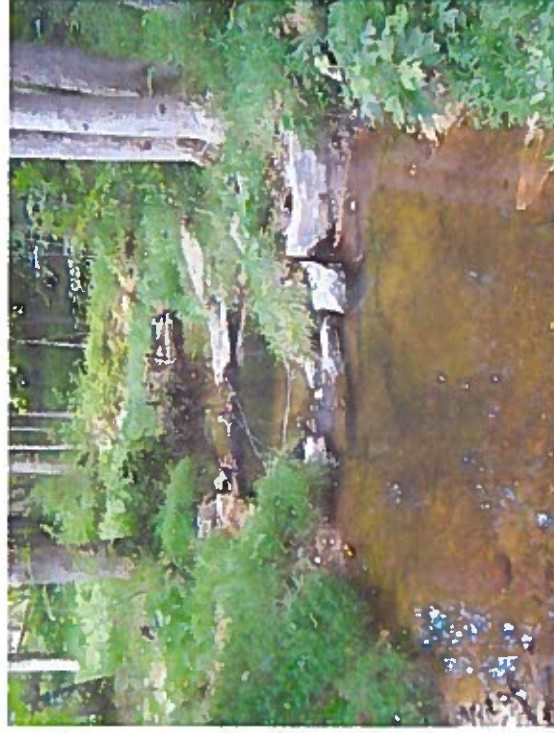
(a) Unstable stream reaches

(b) Same reaches six months after restoration with log/boulder step-pools

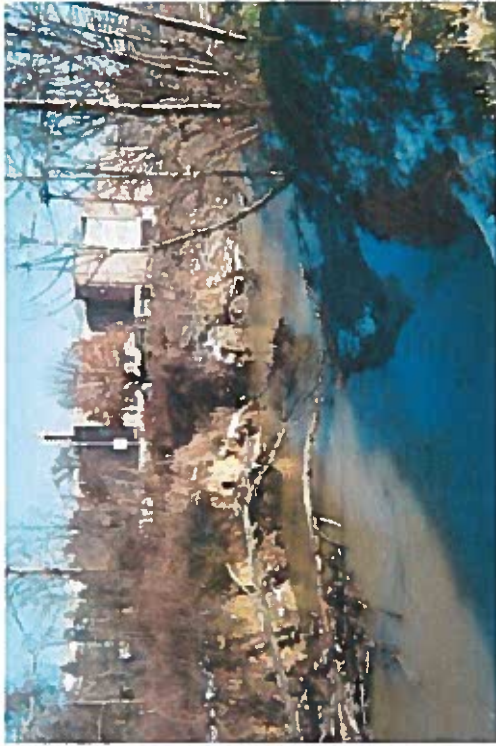
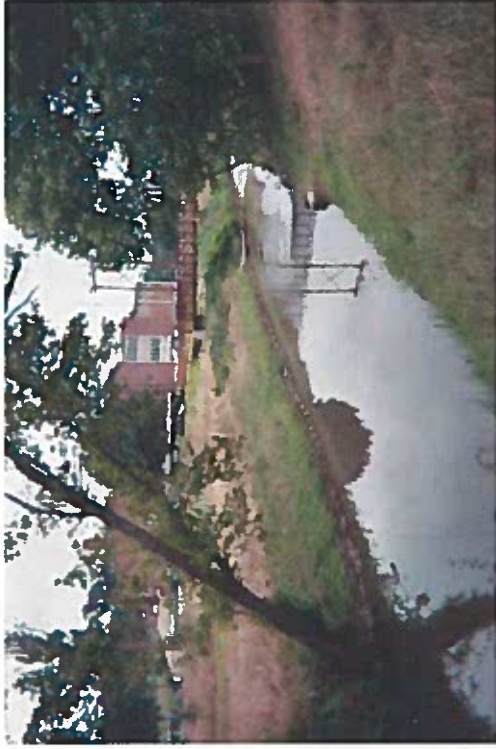
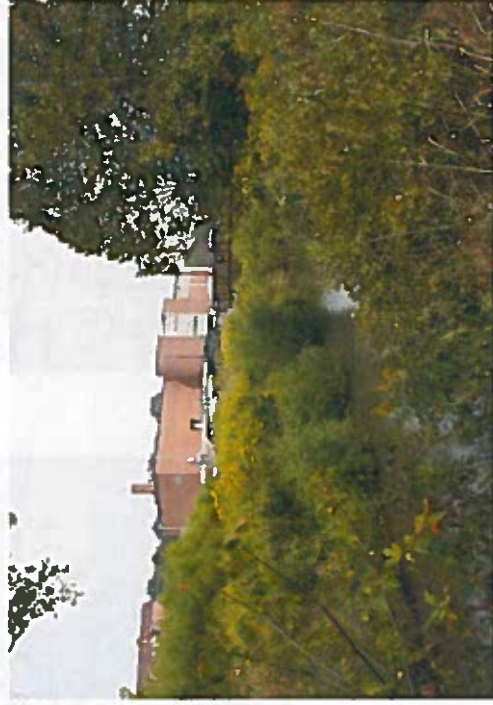
(a) Unstable reach

(b) Four months after restoration with toe benches. Note channel has been narrowed significantly.

(c) Three years after restoration

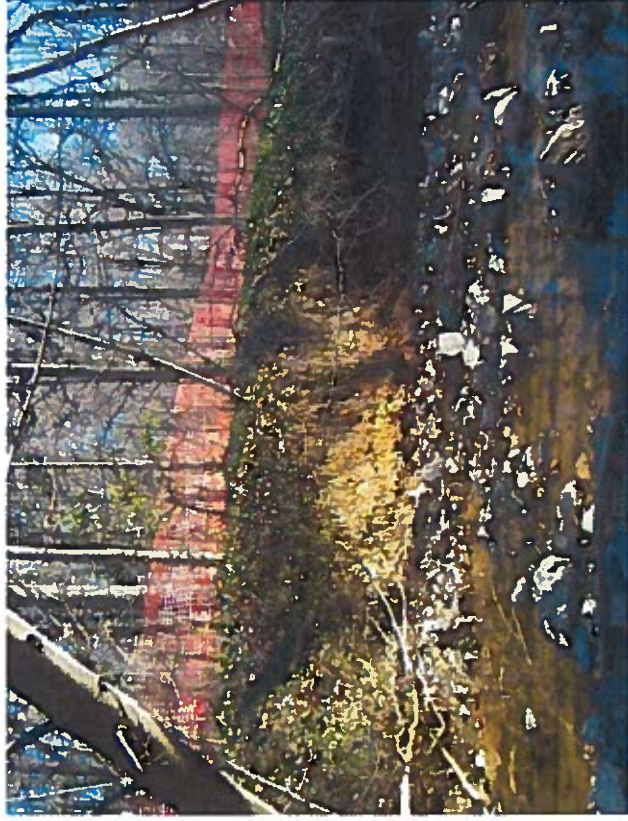
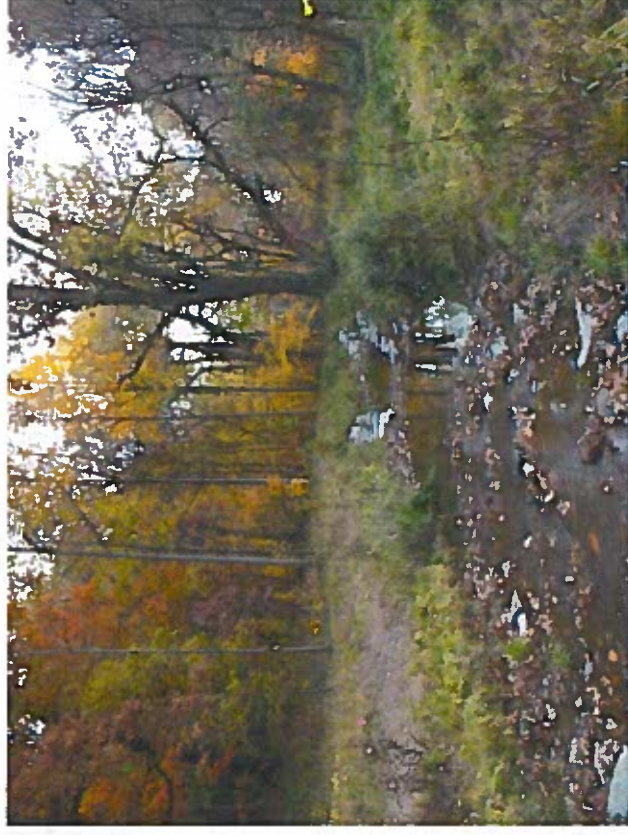
(a) Unstable reach

(b) Same reach six months after restoration with toe benches and soil fabric lifts

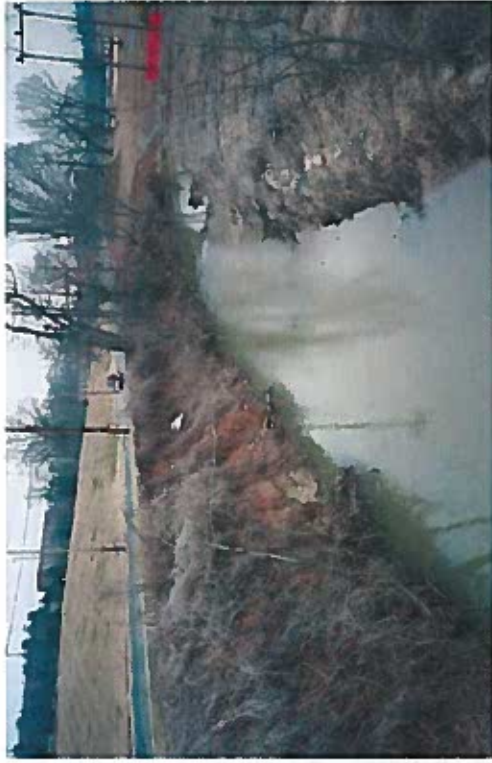
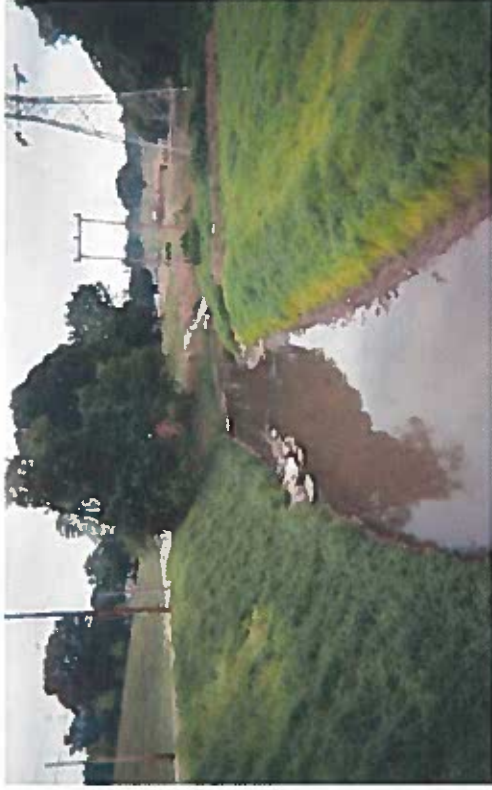
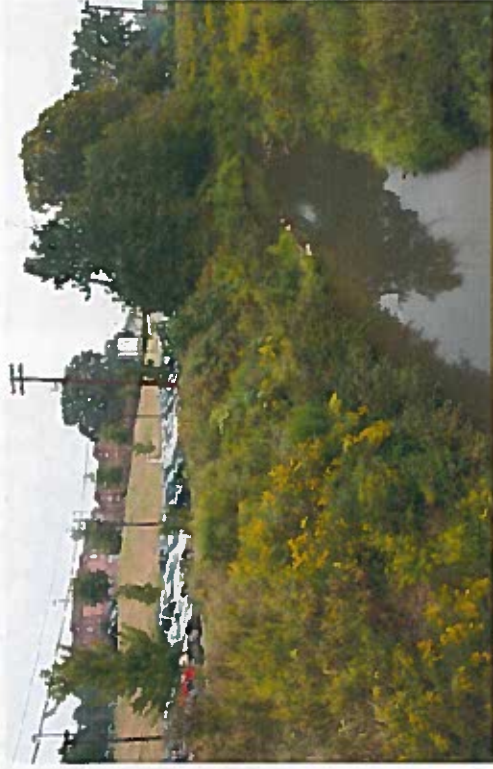
(a) Unstable reach

(b) Same reach four months after restoration with toe benches and soil fabric lifts. Note channel has been shifted away from failing slope and narrowed.

(c) Three years after restoration

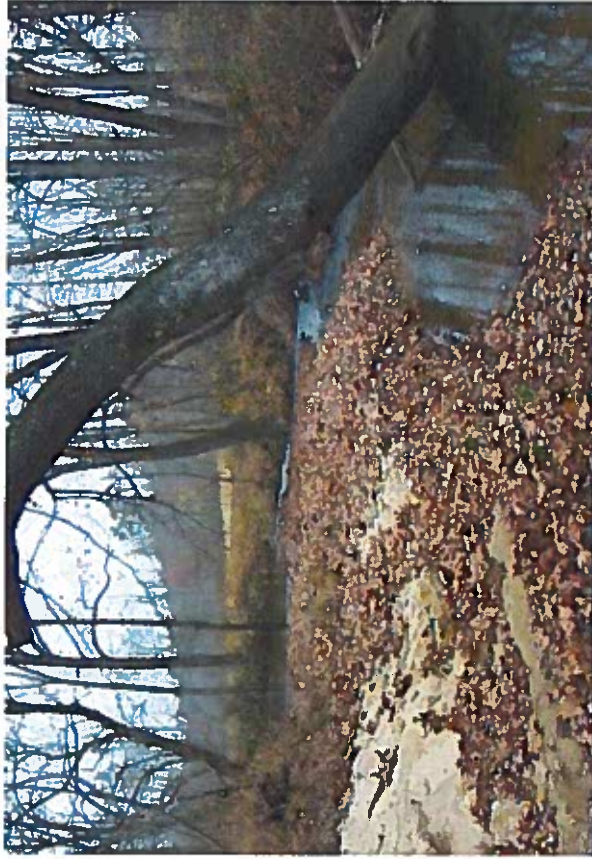
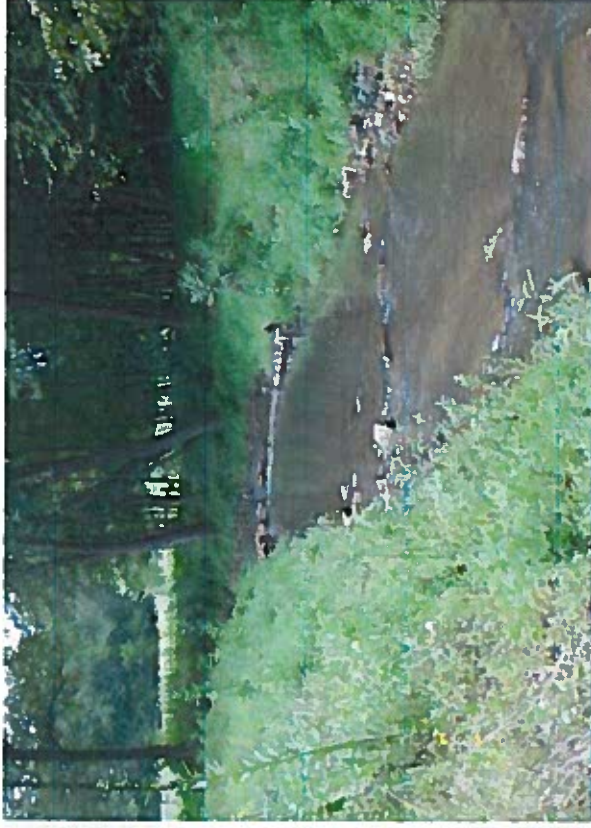
(a) Unstable reach

(b) Same reach one year after restoration. Note channel narrowed and constructed riffle and log-boulder J-Hook installed to provide vertical and lateral control

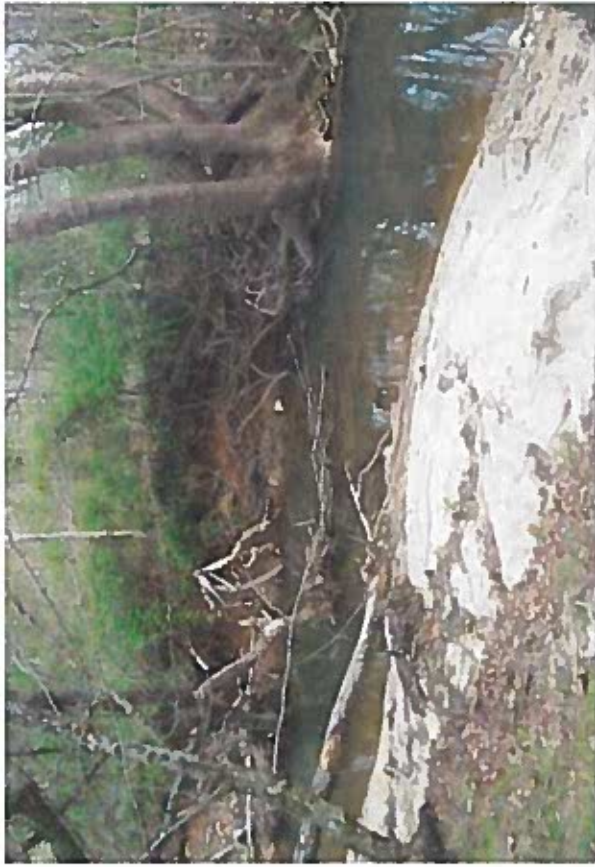
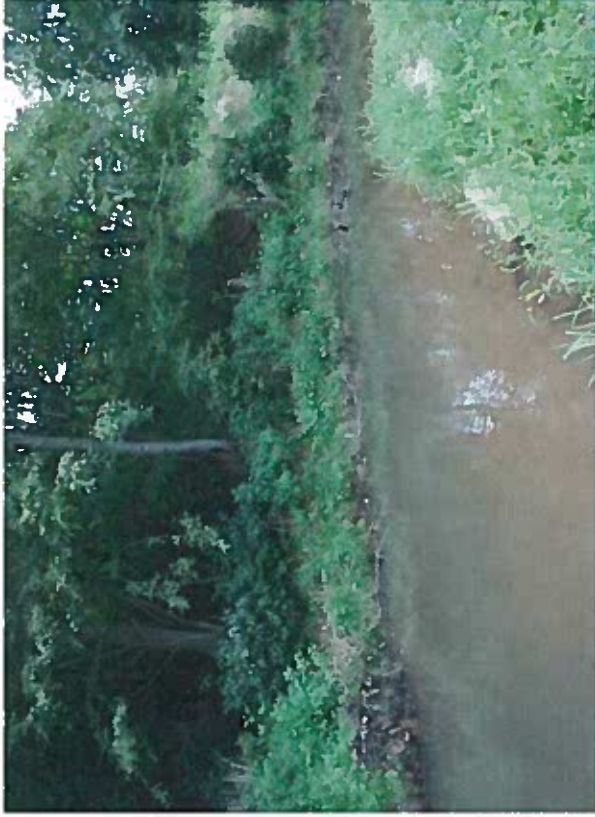
(a) Unstable reach

(b) Same reach one year after restoration. Note channel narrowed and bank reconstructed with toe wood to provide lateral control

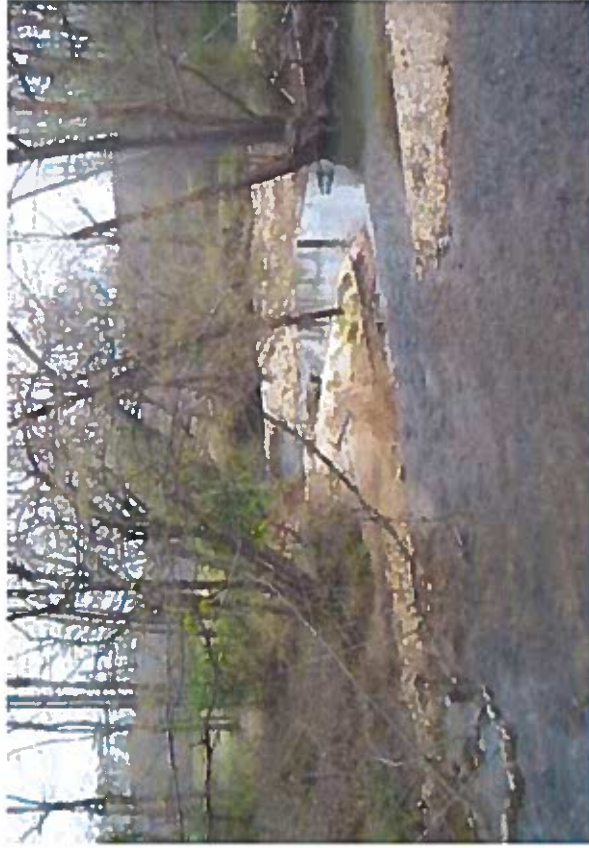
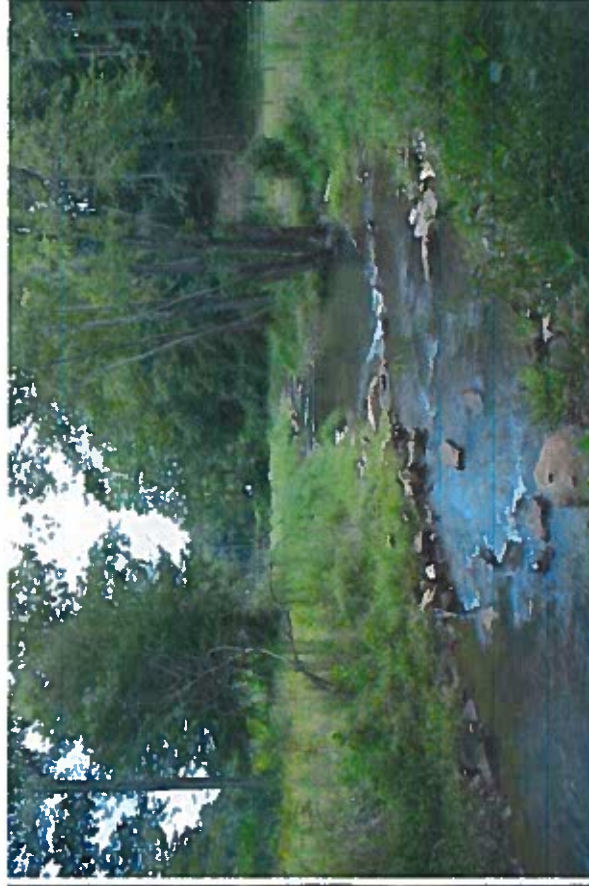
(a) Unstable reach

(b) Same reach one year after restoration. Note meander bends smoothed, channel narrowed and constructed riffle and log-boulder J-Hook installed to provide vertical and lateral control.

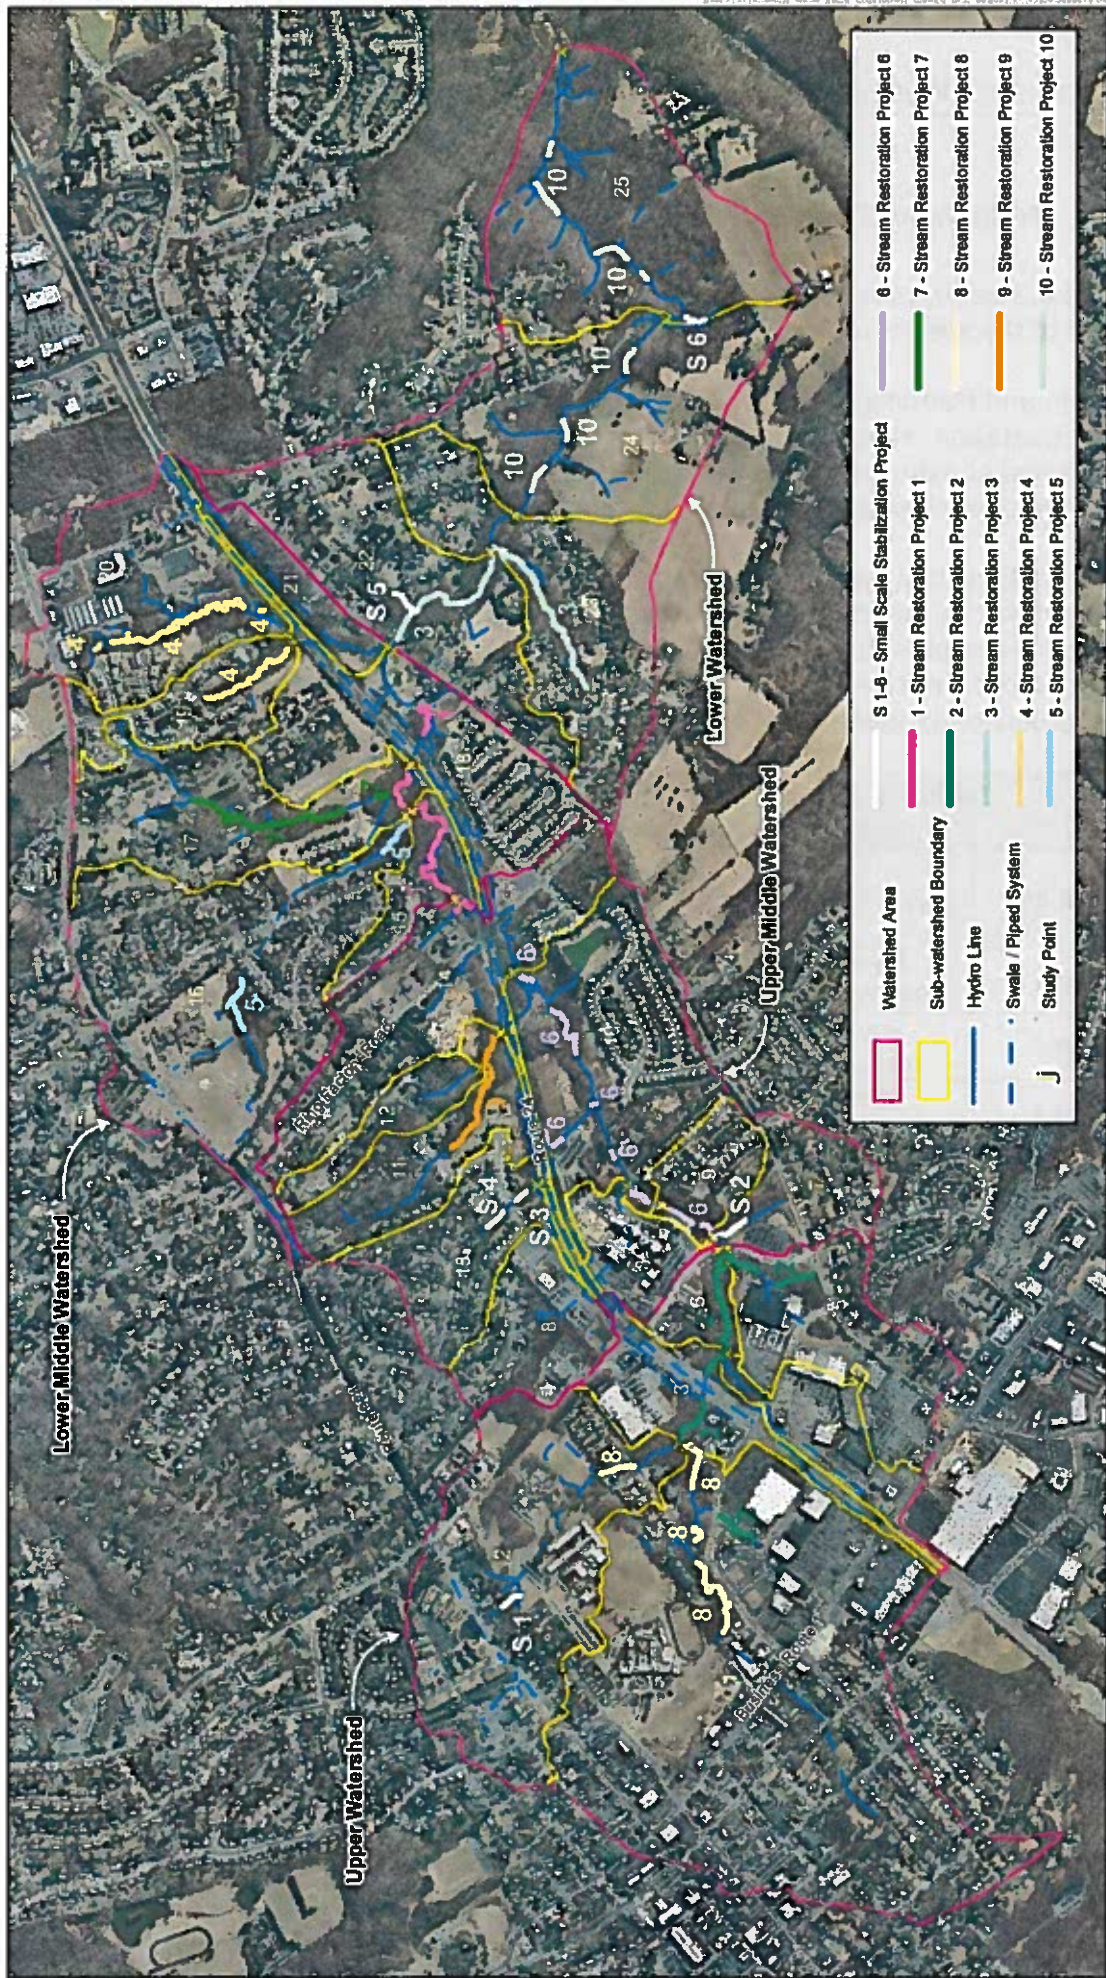
Plumtree Run Watershed Assessment Stream Restoration Projects and Small Scale Stabilization Projects
 Figure 6.11

Project ID Stream Reaches	Length (feet)	Existing Problems	Proposed Solutions
Project 10 (cont'd)			25LMS – The aggradation due to the backwater from reservoir cannot be changed. However, streambanks adjacent to outdoor classroom should be stabilized and footbridge relocated to a point upstream where banks are higher to allow floodwaters to pass beneath structure without damaging it.
Plumtree Run Total	23,219
