Pedestrian Safety Study

**MD 924 (Main Street and Bond Street) from
Baltimore Pike to Lee Street**
Bel Air, Maryland

**Pedestrian Safety Study
MD 924 from Baltimore Pike to Lee Street**

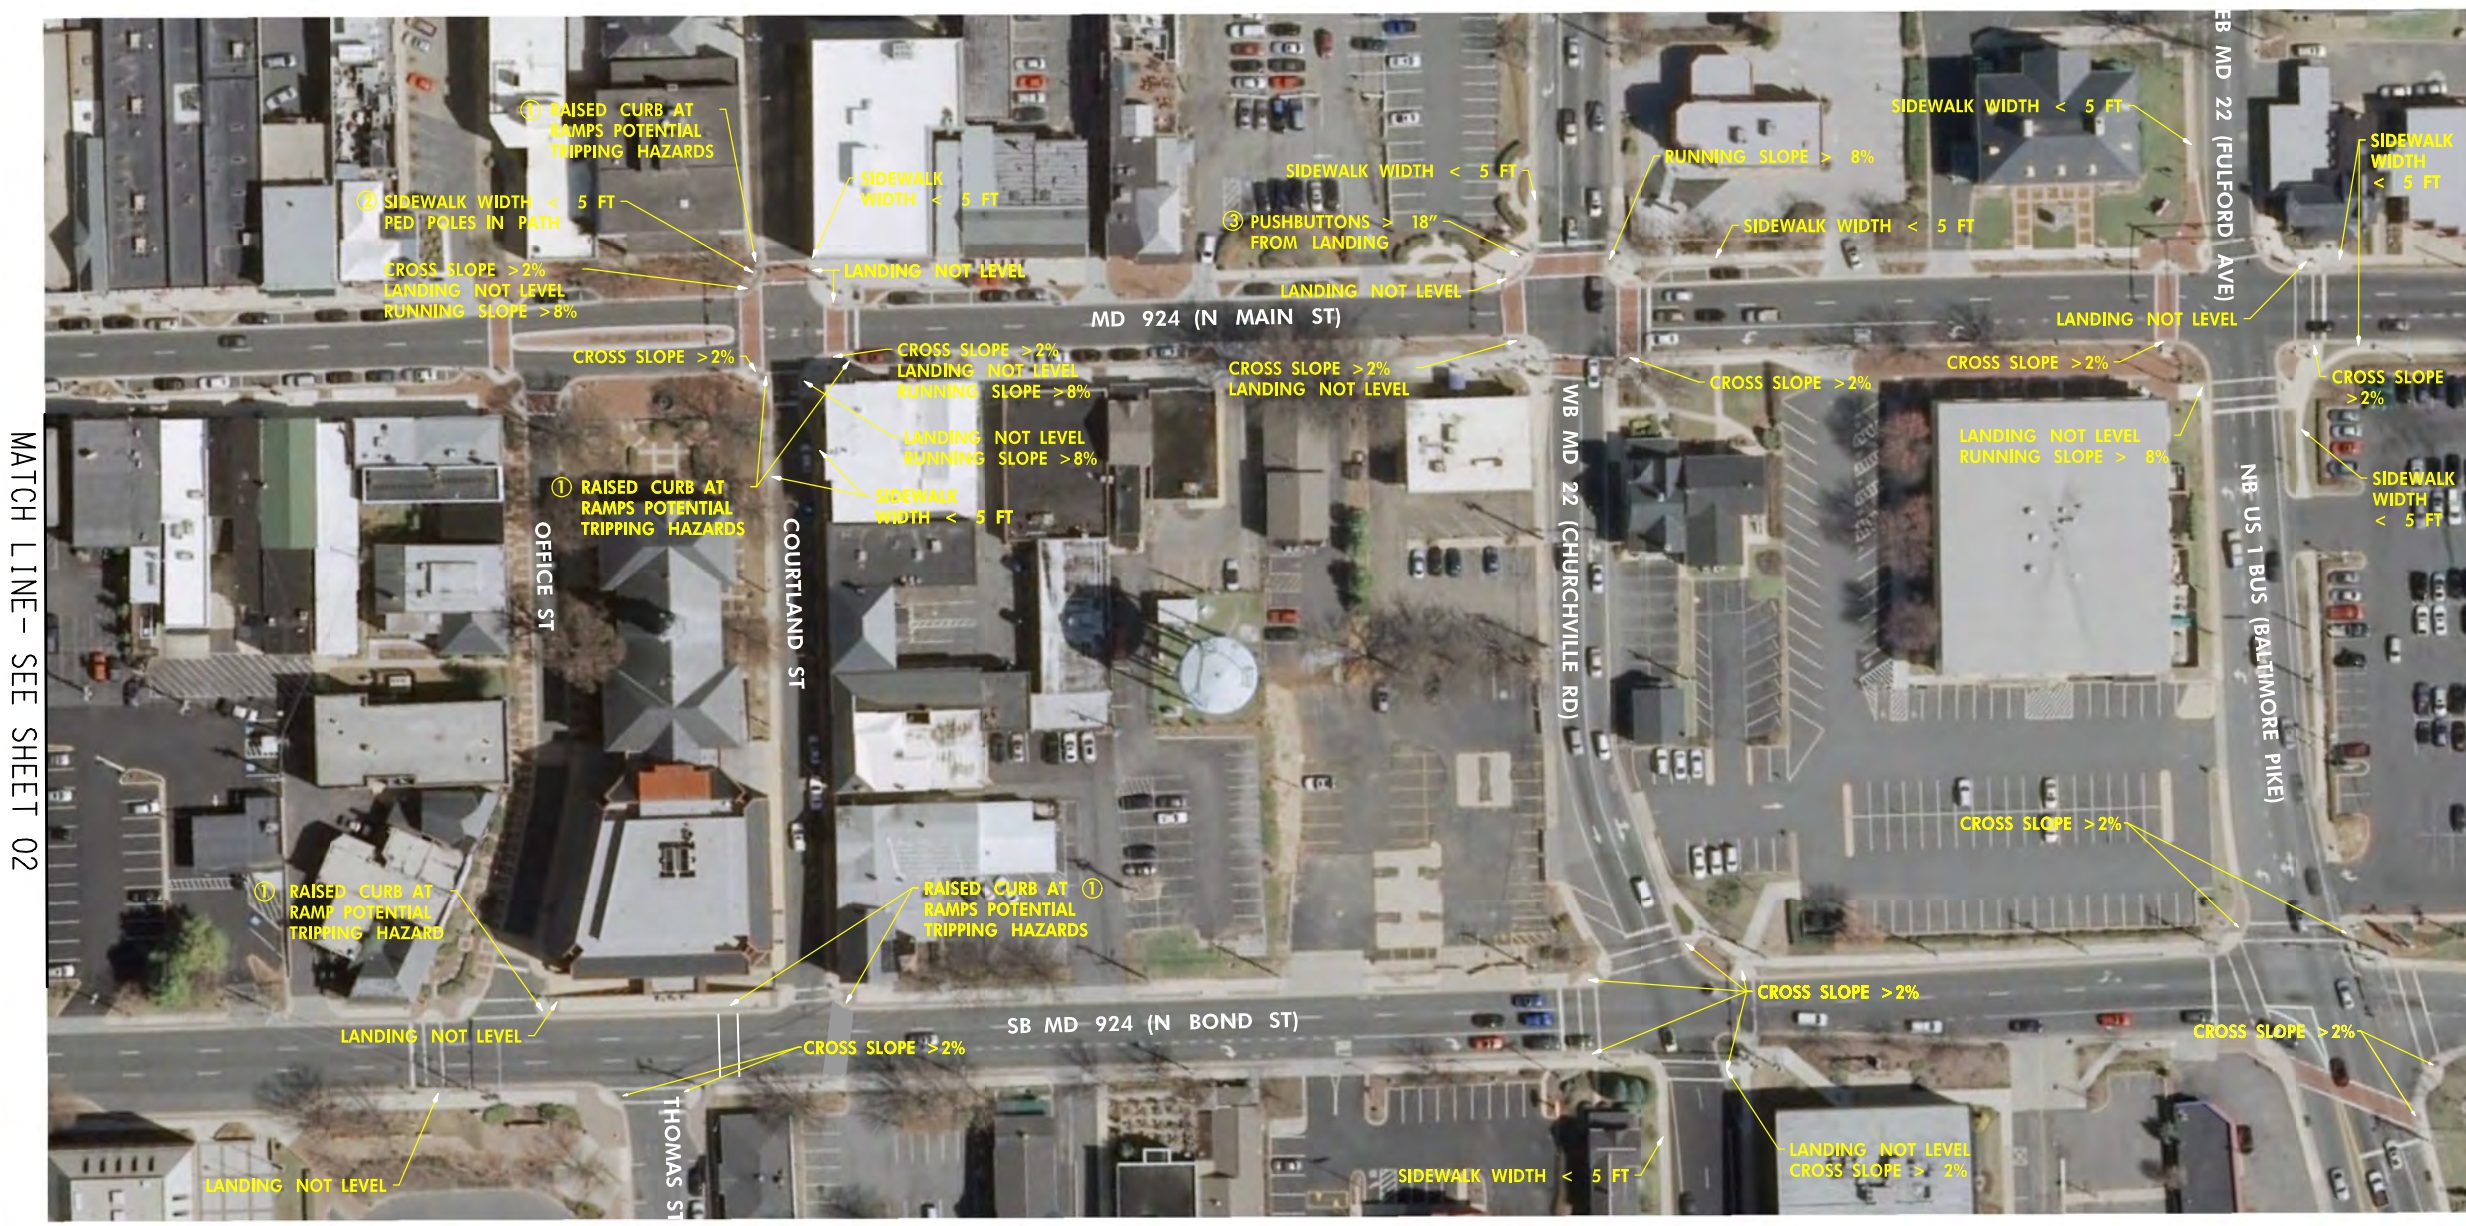
As part of the streetscape improvements completed in 2008, the sidewalks, crossings and pedestrian signals were made ADA compliant in the downtown area, with some deficiencies still present at some of the intersections. A summary of these deficiencies are identified in **Figures 2 and 3**, and a detailed inventory of all the ADA compliant information at each intersection within the study area is provided in **Appendix B**.

1. RECOMMEND RAMP FLARES INSTEAD OF FULL HEIGHT CURBS AT RAMPS.
2. RECOMMEND RELOCATING APS PEDESTAL POLE FOR NORTH LEG CROSSING TO CLEAR SIDEWALK PATH.
3. RECOMMEND RELOCATING PEDESTRIAN PEDESTAL POLE FOR EAST LEG CROSSING CLOSER TO RAMP.

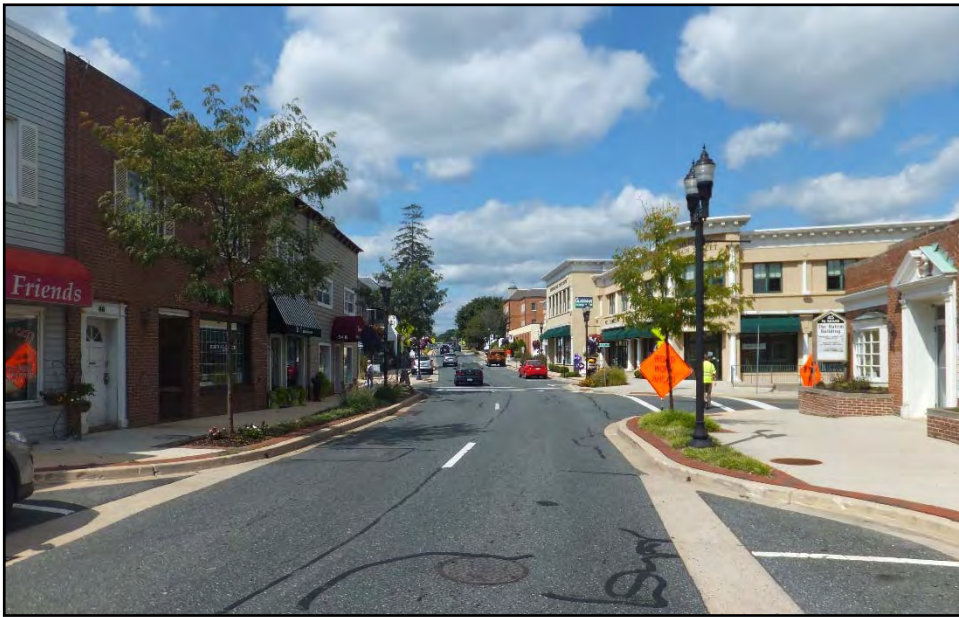
Figure 4. Main Street Approach to Lee Street

The uncontrolled marked crossing at Lee Street across Main Street is located on the north leg between East and West Lee Street. As shown in **Figure 4**, the crosswalk is not hatched and the pedestrian crossing warning signs are obstructed from view of approaching vehicles along Main Street. Providing a marked crossing on the south leg would have a shorter crossing length, no conflicts with right-turning vehicles from West Lee Street, and better sight distance for the pedestrian crossing warning signs.

- a. Install advanced Pedestrian Crossing warning signs (W11-2) along Bond Street in advance of the Lee Street uncontrolled crossing. The Lee Street uncontrolled crossing along Main Street currently has advanced pedestrian warning approach signing.
- b. Install hatching or stamped brick treatment to both Lee Street uncontrolled crossing to improve driver awareness, which would be consistent with other uncontrolled crossings in the area.
- c. Consider relocating or installing a new marked crosswalk crossing Main Street along the south leg at Lee Street. This location would provide a better pedestrian desire line, shorter crossing, no conflict points with right-turning traffic from West Lee Street, and better sight distances from approaching Main Street traffic. See **Figure 8** for the proposed alignment.

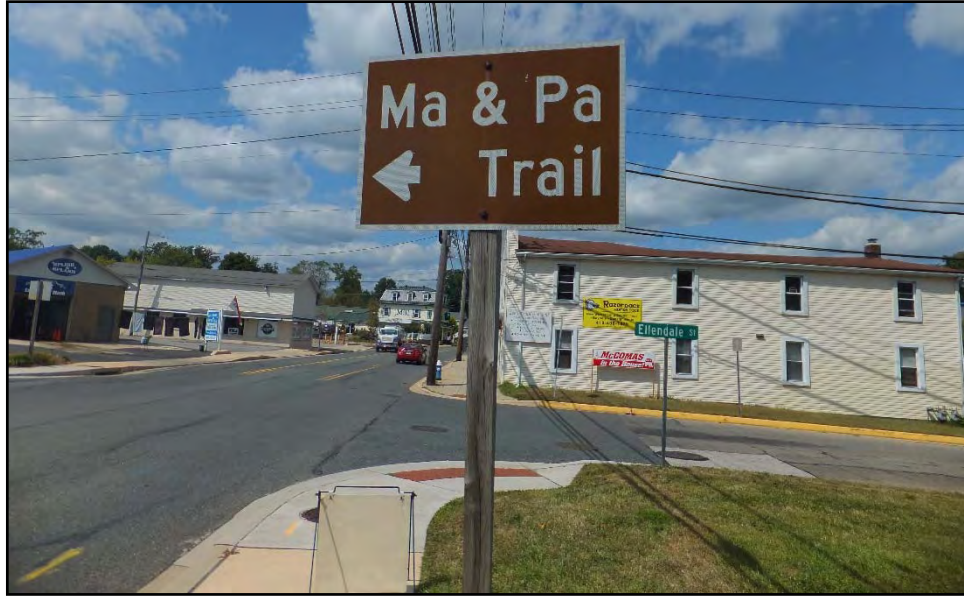
Figure 6. Existing Ma & Pa Trail Sign

The current proposed alignment in the *Bicycle and Pedestrian Plan* has the trail crossing MD 924 at Cressy Road and mid-block just west of Ellendale Street. Trail way-finding signs to direct vehicles to the current trail location are present at the Ellendale Street intersection (see **Figure 6**). Both Cressy Road and Ellendale Street are un-signalized intersections with stop control on the minor street approaches. An existing signalized marked crossing across the north leg at Broadway is located approximately 500 feet south of the current proposed alignments.

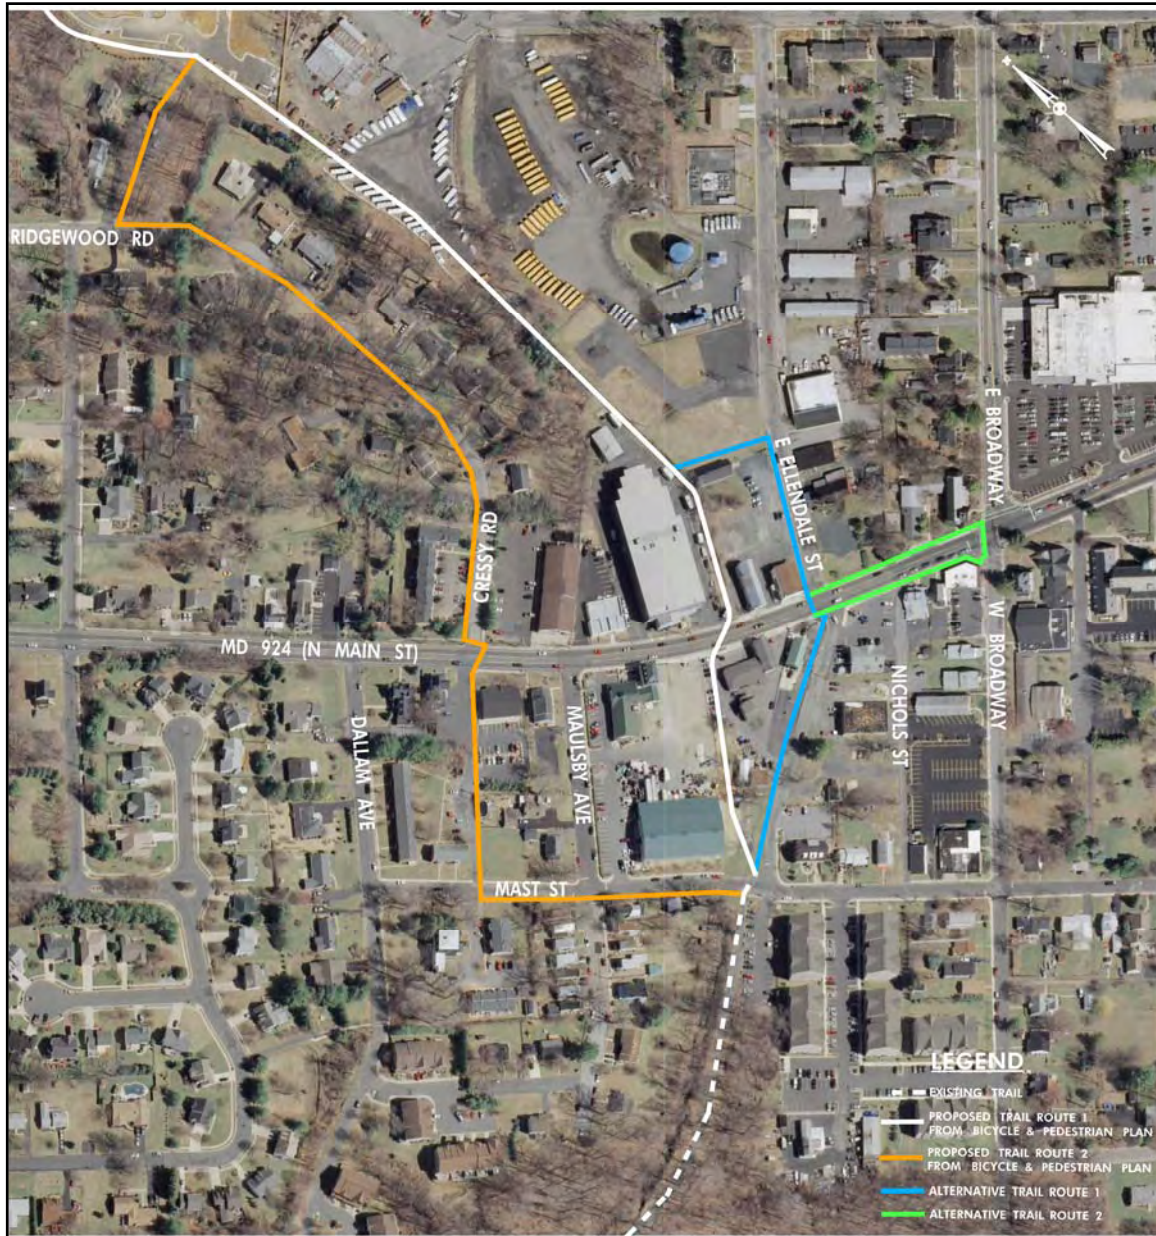
Figure 7. Ma & Pa Trail Proposed Alignments

A revised proposed alignment crossing the north leg of Ellendale Street was evaluated with the current proposed alignments. The current and revised proposed trail alignments are shown in **Figure 7**. Both Cressy Road and Ellendale Street intersections have adequate sight distances (Cressy Road is slightly better) and are feasible locations that can directly connect the existing trail to the proposed alignment to install an un-controlled crossing. The MD 924 crossing should include hatched crosswalk markings and pedestrian crossing signs in advance and at the un-controlled crosswalk. The signalized crossing at Broadway would be a safest means to cross MD 924; however this location does not provide a direct path to the proposed alignment.

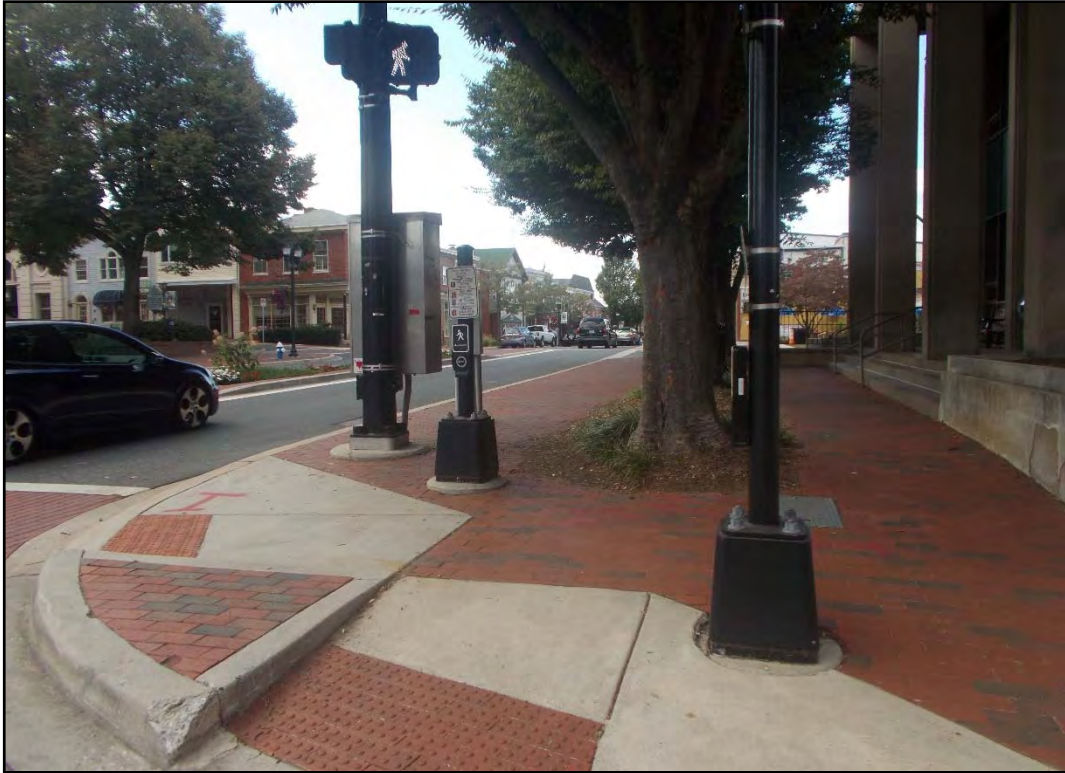
Figure 9. Ramps With Full-Height Curbs Creating Tripping Hazard

- a. Consider reconstructing sidewalk ramps that currently have full-height curbs adjacent to the ramp with properly designed flares to eliminate tripping hazards at the following locations (see **Figure 9** as sample hazard at Courtland Street):
 - Main Street at Courtland Street
 - Main Street at Pennsylvania Avenue
 - Bond Street at Courtland Street
 - Bond Street at Office Street
